National Dam Inspection Program.
Carbondale Number 4 Dam (NDI ID Number
PA-00384, DER ID Number 35-13),
Susquehanna River Basin, Racket Brook,
Lackawanna County, Pennsylvania.

Phase I Inspection Report.

NDI ID No. PA-00384
DER ID No. 35-13

(11) FEBRUARY 1979

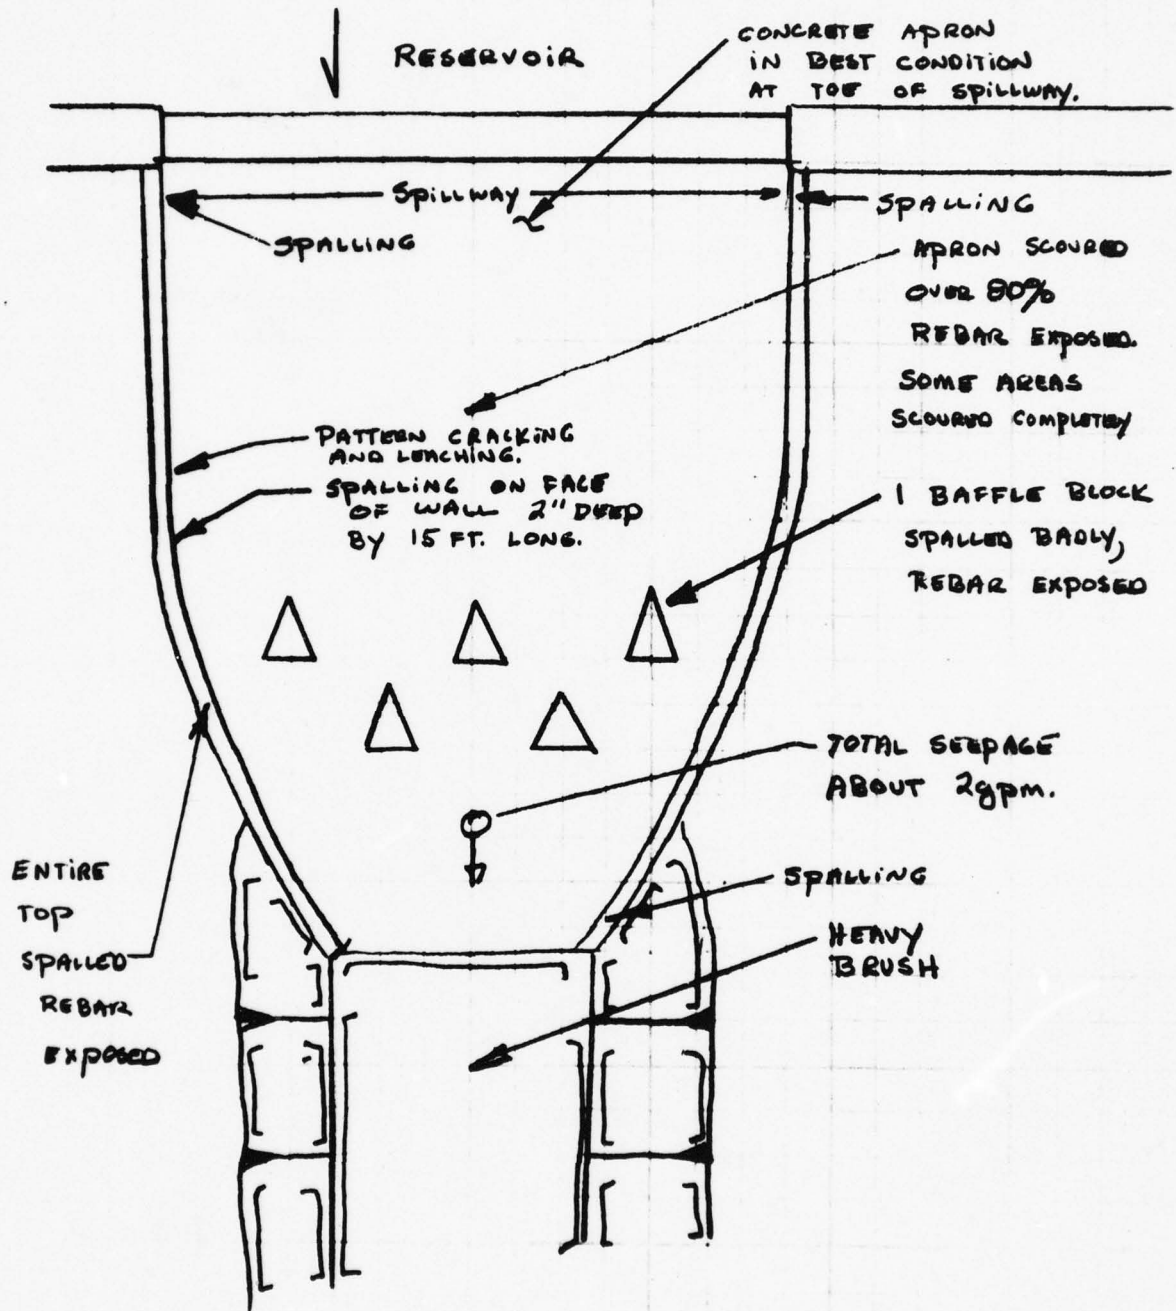
Spillway Outlet Channel

VISUAL EXAMINATION OF	OBSERVATIONS	REMARKS OR RECOMMENDATIONS
CONCRETE WEIR MASONRY	MANY MINOR SEEPS THROUGH MASONRY JOINTS AND 1 MAJOR SEEP 6" below crest - 1 gpm	IN MASONRY TO RIGHT OF SPILLWAY, THE JOINTS ARE SEEPING.
APPROACH CHANNEL	RESERVOIR	
DISCHARGE CHANNEL	SEE SKETCH ON NEXT SHEET	
BRIDGE AND PIERS	NONE

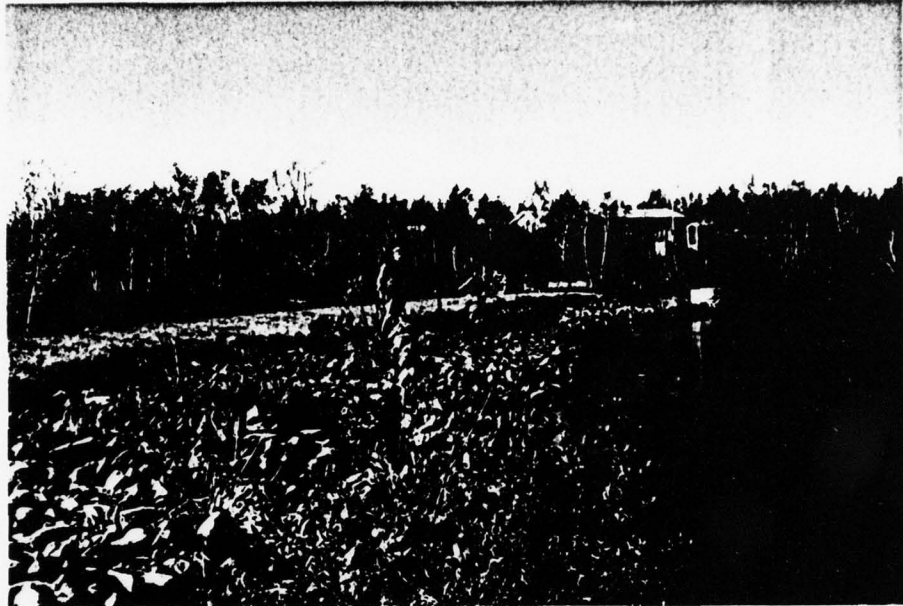
A. Upstream Slope

<u>Feature and Location</u>	<u>Observed Deficiency</u>
<u>Embankment:</u>	
Upstream slope	Trees and brush
Top	Below design elevation
<u>Spillway:</u>	
Weir	Deteriorated mortar
Stilling Basin	Spalling, pattern cracking, scour, and leaching.
Downstream channel	Brush

- (1) Raise the top of the dam to the design elevation.
- (2) Repair the concrete in the stilling basin and the mortar in the spillway weir masonry joints.
- (3) Remove the brush from the embankment slopes and from the spillway discharge channel.

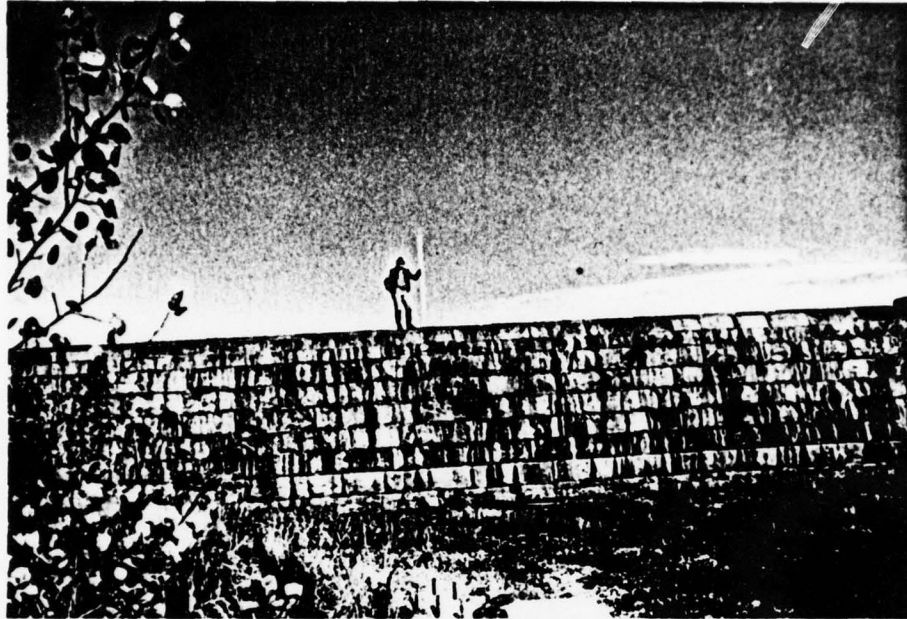
C. Spillway

The spillway is in fair condition. There is a flow of about 1 gpm seeping from a joint located a few inches below the crest. There is seepage from many other joints. The seepage is from both the joints in the spillway and those immediately to the right of the spillway (Photograph C).

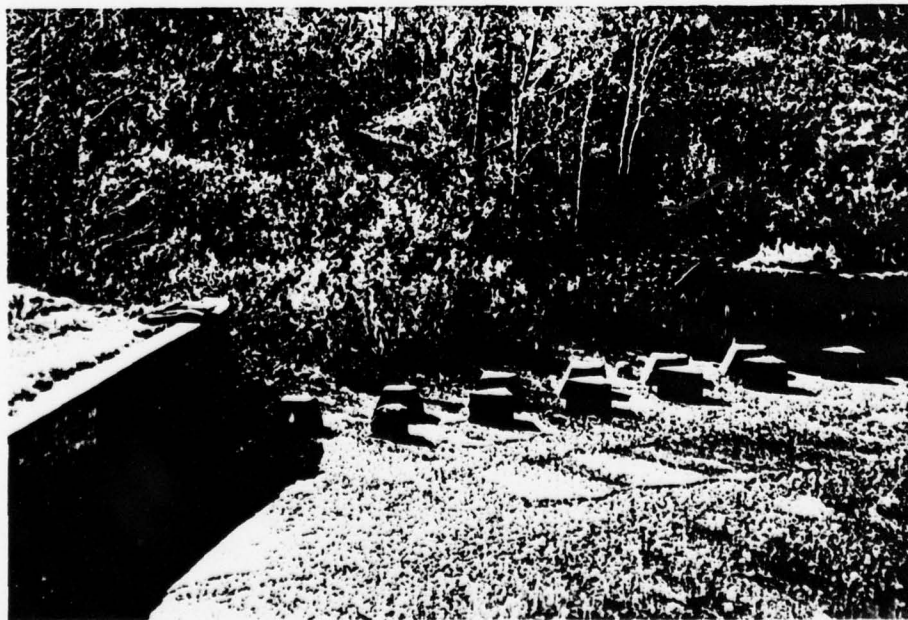
D. Spillway Outlet Channel

There are many deficiencies in the stilling basin (Photograph D). One baffle block is badly spalled. Pattern cracking and leaching were observed at the right wall. The right wall is badly spalled in many areas. The reinforcing bars are exposed along the top of this wall. There is also some spalling at the left wall near its junction with the spillway. About 80 percent of the bottom of the stilling basin is scoured. In some areas, the concrete appears to have scoured completely. A total flow of 2 gpm was observed in the stilling basin. It was not possible to determine whether this flow was seeping from beneath the stilling basin or whether it was the accumulated seepage from the spillway joints.

The brush in the spillway outlet channel will reduce its carrying capacity. The backwater effect will not reduce the spillway discharge capacity. However, it may cause overtopping of the stilling basin

walls. If the walls should overtop, erosion of the downstream earthfill would occur. Although undesirable, it would not create a significant hazard to the embankment.
